# OPERATION **PLUMB BOB**

Project 3.2

EVALUATION of BURIED CONDUITS  
as PERSONNEL SHELTERS

OPERATION PLUMBBOB—PROJECT 3.2

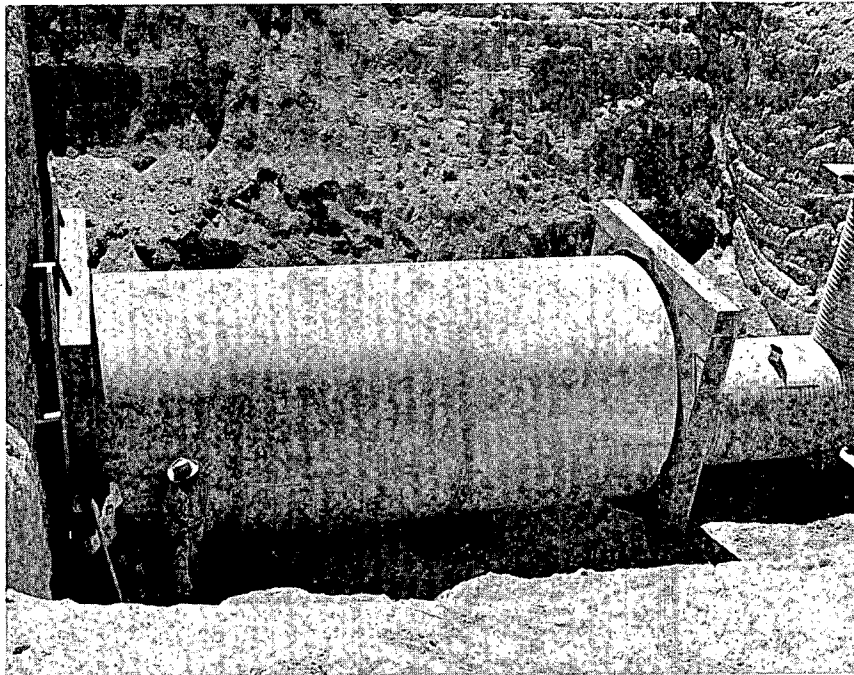
Figure 2.16 Exterior view of typical circular concrete conduit prior to backfilling.

time of assembly. The conduit sections were assembled as indicated in Figures 2.15, 2.16, 2.17, and 2.18.

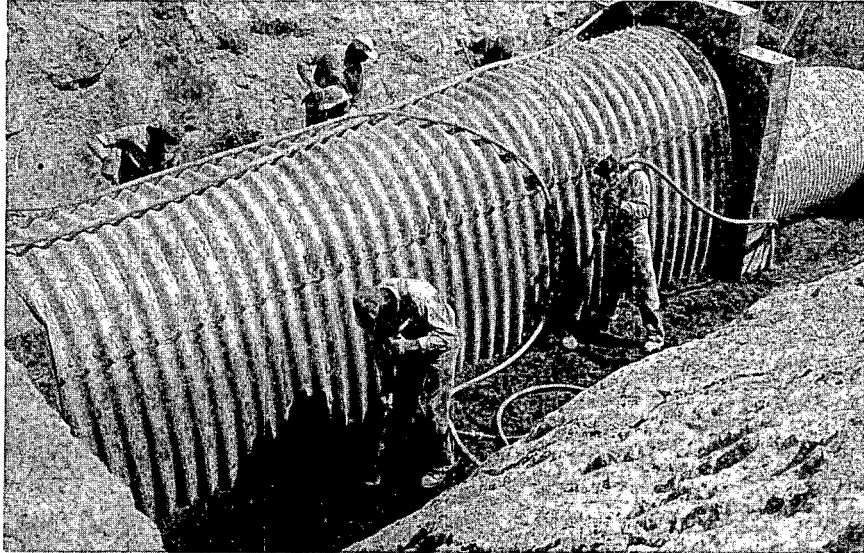
Figure A.7 Tamping backfill with pneumatic tamper.

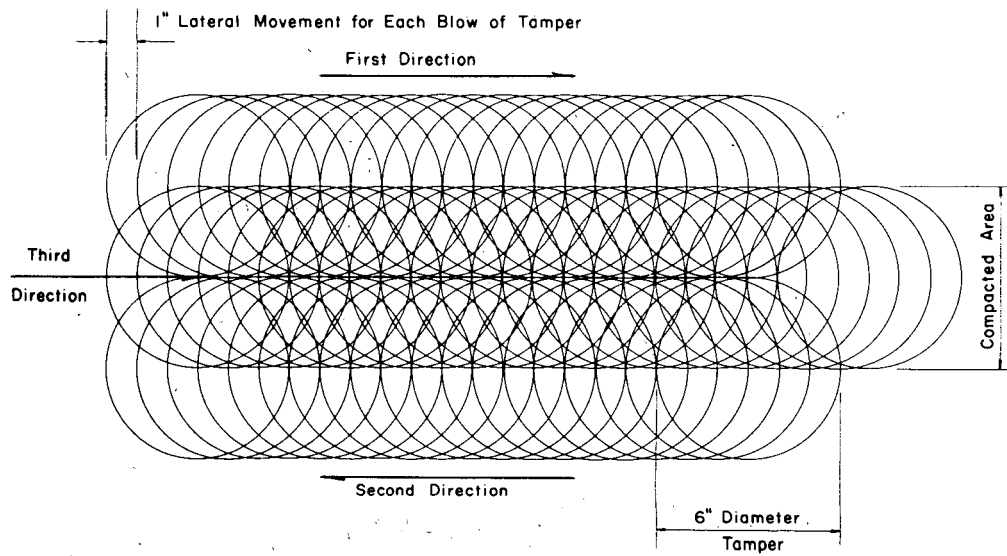
Figure A.8 Tamper compaction pattern.

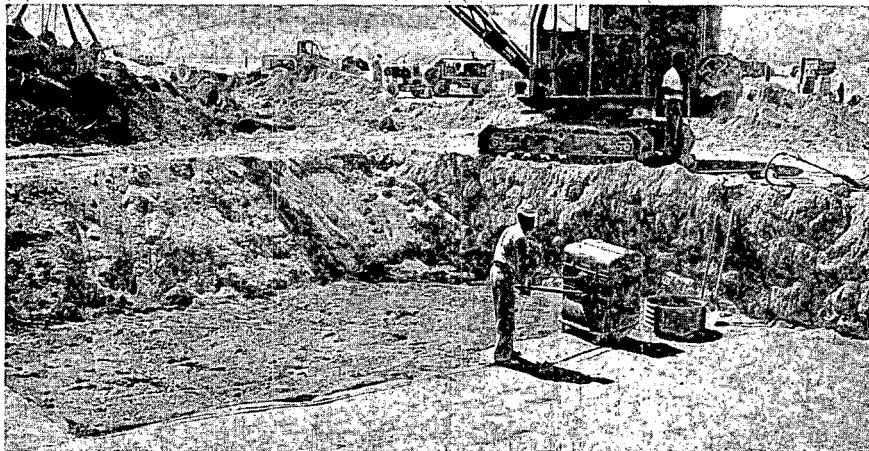
Figure A.9 Compacting backfill with gasoline-driven vibrating roller.

compactor is indicated in Figure A.9. From a level 3 feet above each conduit to the level of the original surface a D-8 Cat crawler tractor (bearing pressures approximately 10 psi) was used for compaction by making four passes over each area.

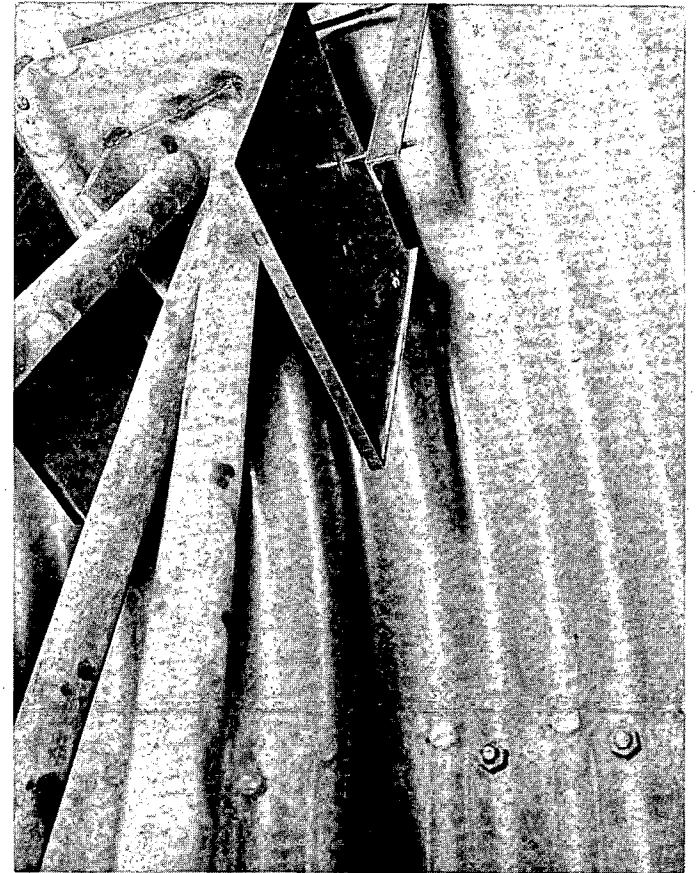
Figure B.2 Scratch deflection gage installed inside conduit.

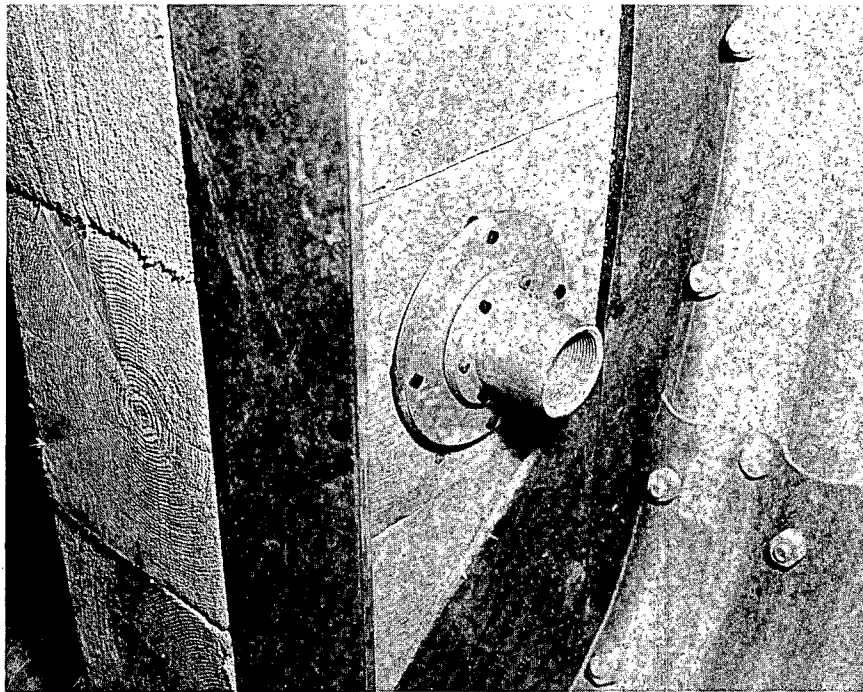
Figure B.6 Peak pressure gage installed on timber bulkhead at access-end of conduit.
